Manhole Inspection Summary

Manhole # S41A2_006MH

Insp Date: **3/24/09 11:04 PM**

Location Address: **Pontiac Ave**

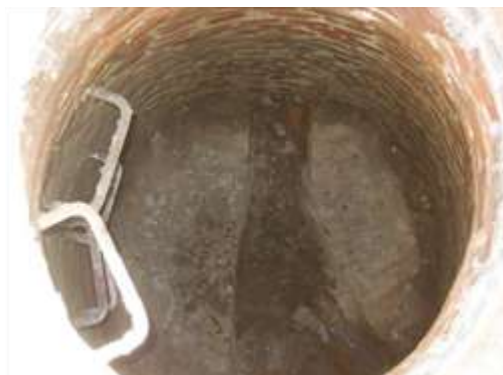
Top View

6 Oclock position plugged.

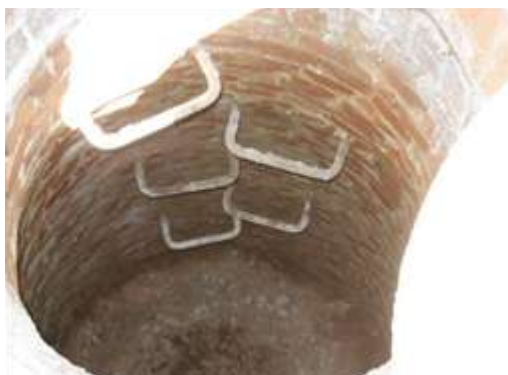
Steps Count: **5** Missing: **0** ☐ Corroded

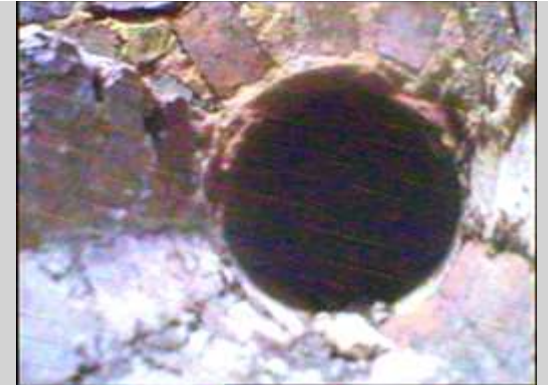
12 O'Clock Outflow

8 in. Circular Gravity Sewer
Pipe Out @ 12 O'Clock

Pipe Height: **9.6** (in.) Rod and Bar (Angled)
Pipe Material: **Clay** ☐ Pipe Lined
Invert Depth: **10.20** (ft.) Flow Characteristics: **None**
Deposits: ☒ None ☐ Mud ☐ Sludge ☐ Debris ☐ Grease
Silt Depth: (in.) Deposits Extent:
Infiltration: **None** Pipe Seal Cond: **Sound**

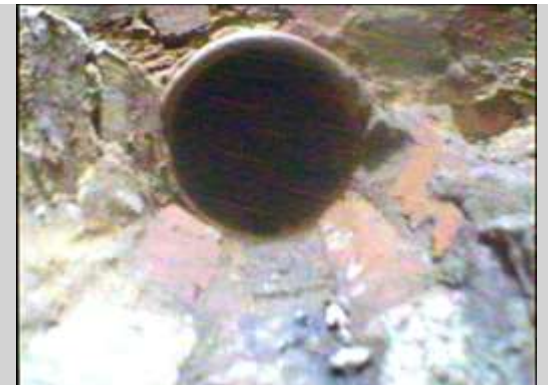
4 O'Clock Inflow

6 in. Circular Gravity Sewer
Pipe In @ 4 O'Clock

Pipe Height: **7.2** (in.) Rod and Bar (Angled)
Pipe Material: **Clay** ☐ Pipe Lined
Invert Depth: **9.70** (ft.) Flow Characteristics: **None**
Deposits: ☒ None ☐ Mud ☐ Sludge ☐ Debris ☐ Grease
Silt Depth: (in.) Deposits Extent:
Infiltration: **None** Pipe Seal Cond: **Sound**
